LANDSLIDES AND RELATED FEATURES

OF THE SUNRISE, VA.—W. VA. QUADRANGLE
by
Robert J. Hackman and Roger E. Thomas
1980

U.S. Geological Survey

OPEN FILE MAP 80-194 (B-2)

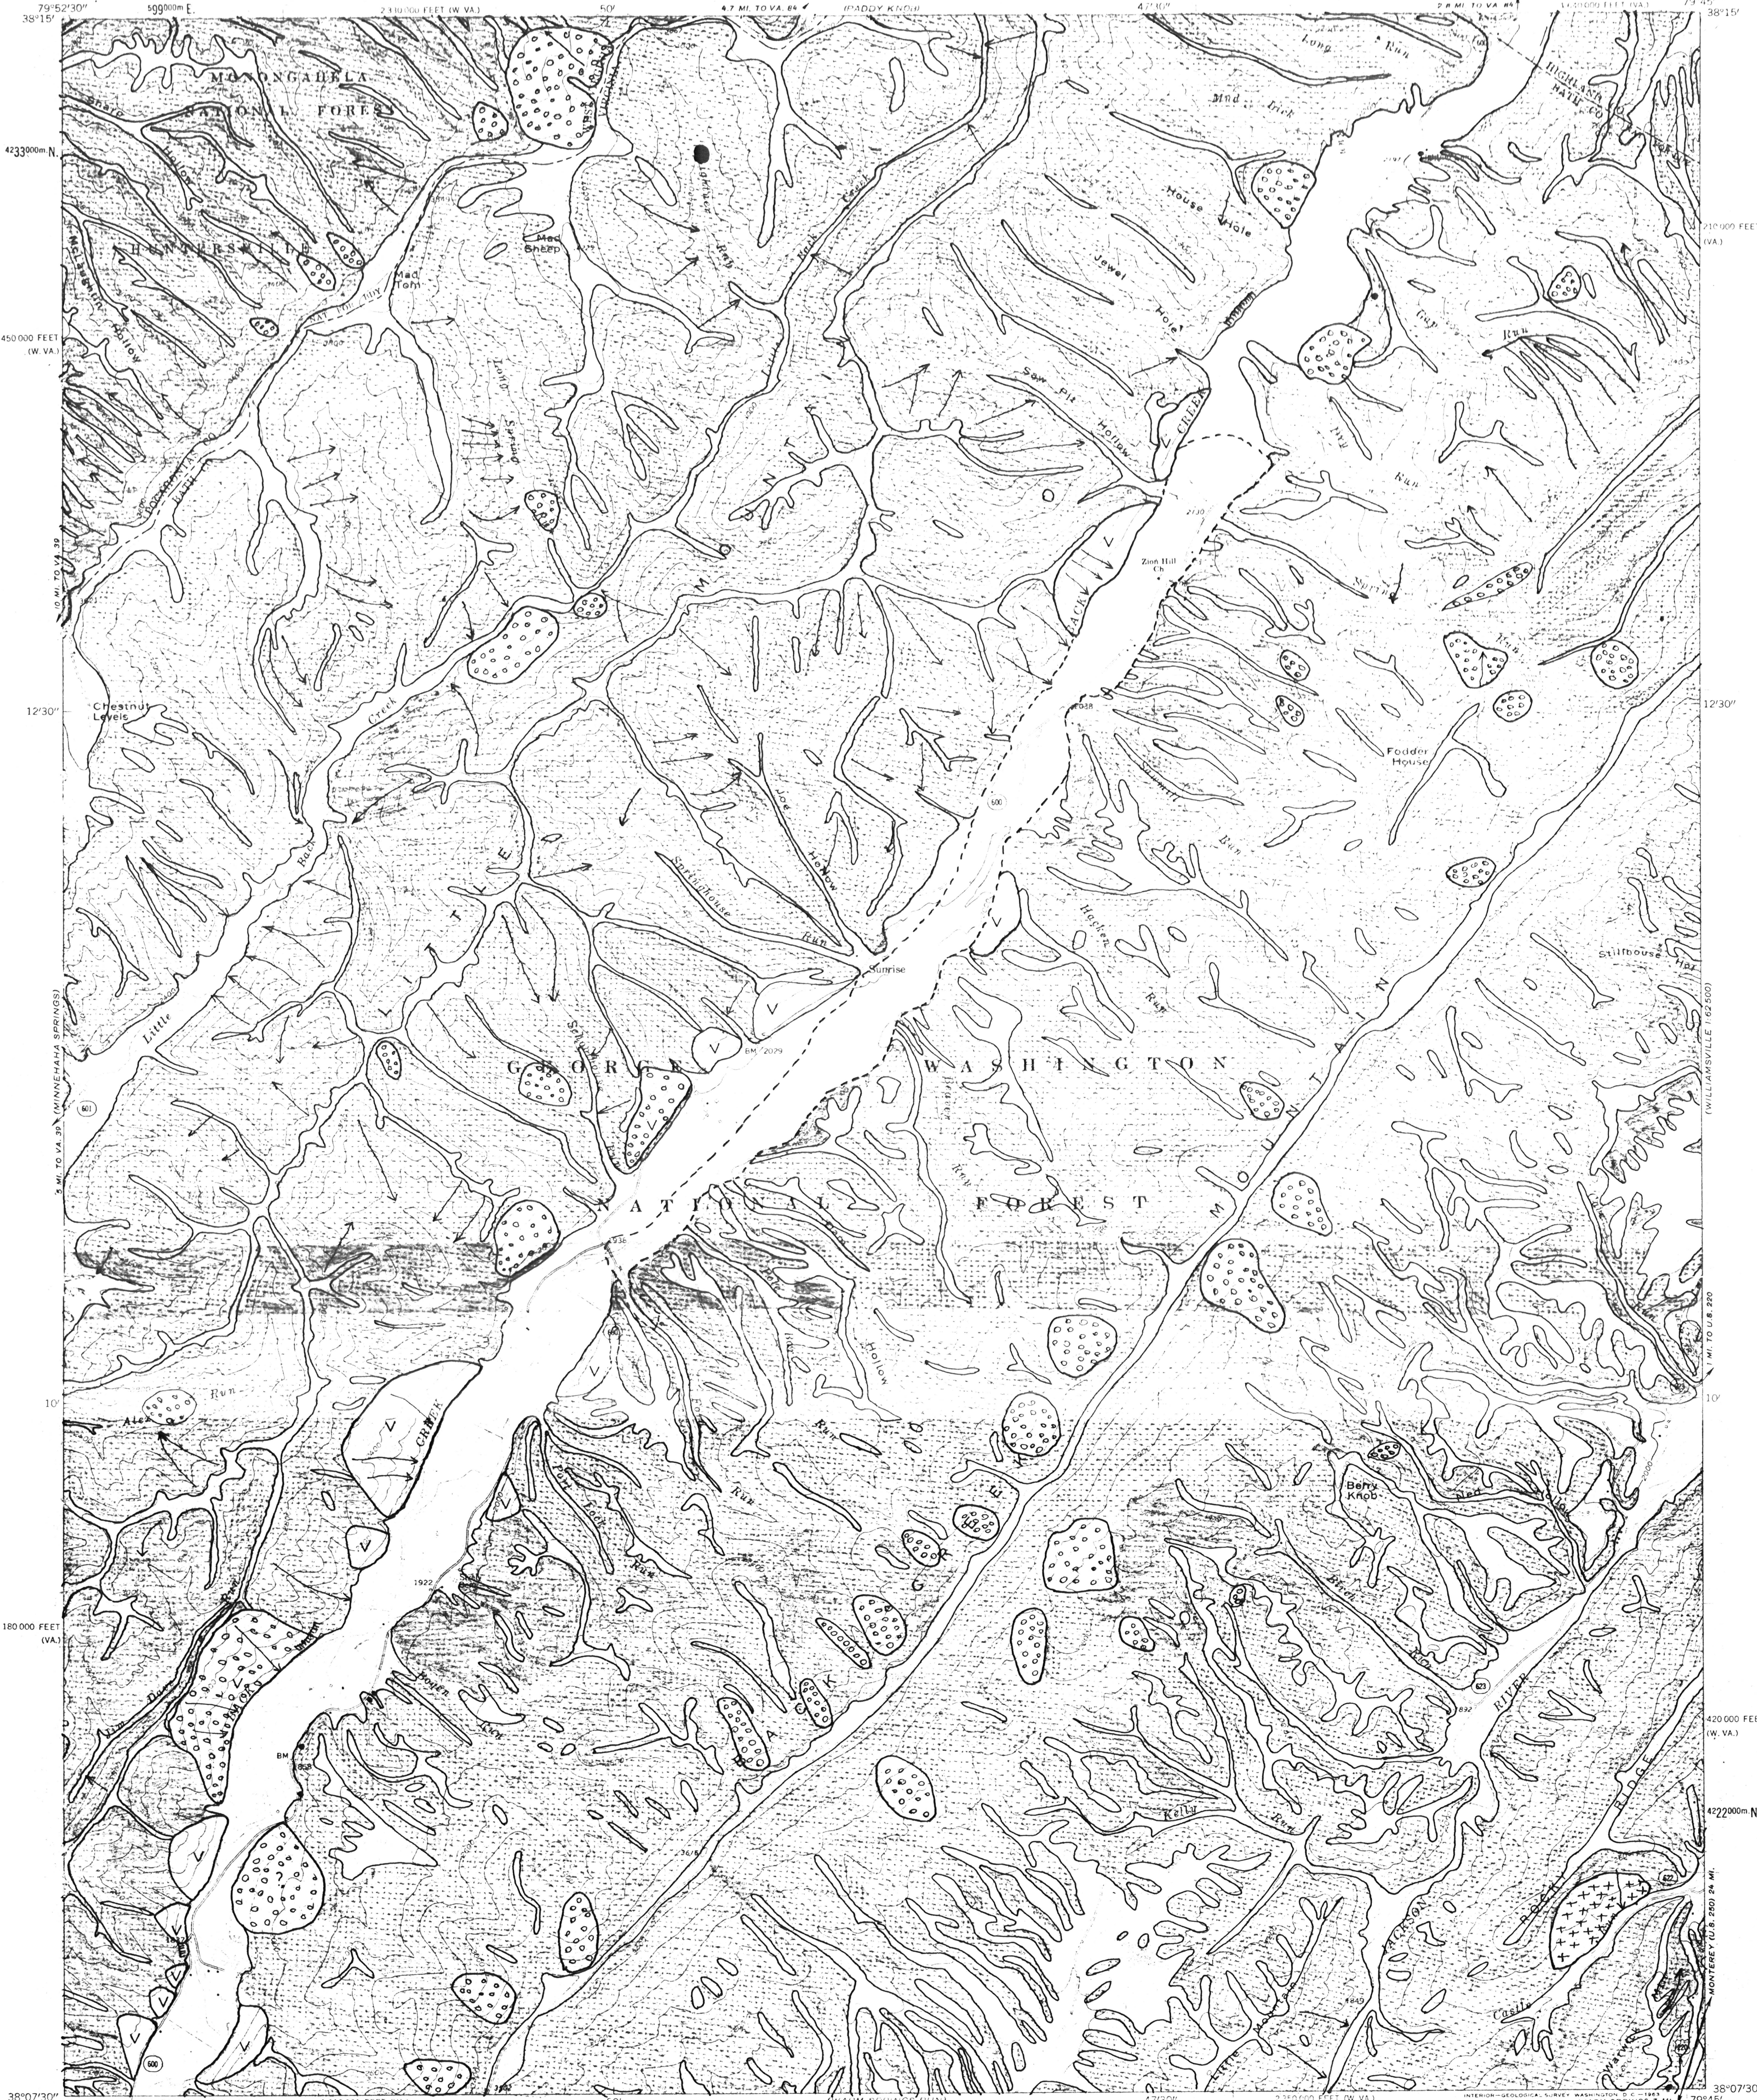
ACTIVE OR RECENTLY ACTIVE LANDSLIDE
Complex landslide composed of earthflow, debris
slide, earth and rock slump. Identified from
historical records, and from scars, debris and
other field evidence. Ground extremely unstable;
sliding accelerated by excavation, loading and
changes in drainage conditions. May include
areas with several active slides too small to
be shown separately. Questioned where doubtful.

OLD LANDSLIDE
Area of extensive hummocky ground caused by
earthflow and earth and rock slump. Lacks
clear evidence of active sliding. Relatively
stable in natural, undisturbed state,
generally not affected by small structures properly
sited in areas away from the edge of the toe;
can be reactivated by extensive, rapid exca-
vation, loading, and changes in ground water and
surface water conditions. Area of old landslide
probably includes recent ones not identified
from field evidence or otherwise documented.
Upslope boundary of landslide generally defined
by modified scarp, but downslope (toe) may be
gradational and not well defined. Questioned
where doubtful.

COMBINATION LANDSLIDE
Area of recent and old slides in which
individual slides are not identified.

COLLUVIAL SLOPE
Valley wall along major streams with slope as
steep as 40° (85%); stony, clayey silt soil up
to 50 ft. (15 m) thick; commonly buttressed by
a terrace or bench at the toe of the slope; very
susceptible to sliding by cutting of toe area,
removal of terrace or bench, and overloading;
slide commonly activated without apparent cause.

COLLUVIAL SLOPES WITH LANDSLIDES
Landslides too small or obscure to map
individually.

**AREAS SUSCEPTIBLE TO DEBRIS FLOWS AND DEBRIS
AVALANCHES**
Primarily shallow, narrow ravines and chutes with
accumulation of debris colluvium generally 10 ft.
(3 m) or less in thickness; susceptible to rapid
movement during intense rainfall. Most ravines
and chutes described show evidence of former
debris flows and avalanches. Symbol **a** design-
ates historical debris flow or debris avalanche.

AREAS SUSCEPTIBLE TO ROCKFALL
Steep, locally vertical, natural and man-made
slopes and cliffs, 15 ft. (4.5 m) or more high;
formed dominantly of sandstone, limestone, sandy
shale, mudstone and claystone. Interbedded mud-
stone, claystone and shale weather rapidly leaving
sandstone and limestone rock faces unsupported.

SOIL AND ROCK SUSCEPTIBLE TO LANDSLIDING
Soil and rock similar to that involved in land-
slides elsewhere in map area; primarily areas
underlain by claystone, mudstone and shale
associated with other rock types. Rock weathers
rapidly on exposure forming clayey soil highly
susceptible to sliding. Includes coves (U-shaped,
shallow valleys) containing thick layers of clayey
soil that are very susceptible to sliding where
excavation breaks continuity of slope and where
overloaded by artificial fill.

AREAS LEAST PRONE TO LANDSLIDES
Map areas in which no patterns or symbols are shown;
primarily valley floors, ridge tops and broad
benches; modification by excavation and fill may
lead to local landslides.

MAN-MADE FEATURES
Strip mines (combination of letter symbols
indicates complex formed of more than one
type of strip mine)
sh bench with high wall
sf furrowed with high wall
sd multiple benches and multiple benches
ss hilltop removed
srg reclaimed by grading
sru reclaimed by secondary use
sh/r regraded in part, high wall
remains
Coal refuse banks
r identified on aerial photographs;
not classified in field check
rb not burnt nor on fire
rbb burnt
rbd burning
rbs sludge
Quarries
q quarry site
qub spoil bank, quarry waste
Gravel pits
g site of gravel pit
Slides in man-made features
af earth flow in fill
a/s earth flow in strip castings
a/r earth flow in coal refuse

NOTE
Information shown is intended as a
general guide to ground conditions as of
the date of field check. Additional
landslides and rockfalls should be anticipated
in all map units. The map unit depicts
the dominant condition in the area delineated
and variations in slope stability may occur
at any point in the unit. This map is suit-
able for general planning purposes and as a
supplement to more detailed studies for site
selection. The map cannot be used as a sub-
stitute for detailed geologic and engineering
investigations to establish design and
construction criteria of specific sites.
Some symbols may not appear on this map
because the description is applicable to a
series of maps.

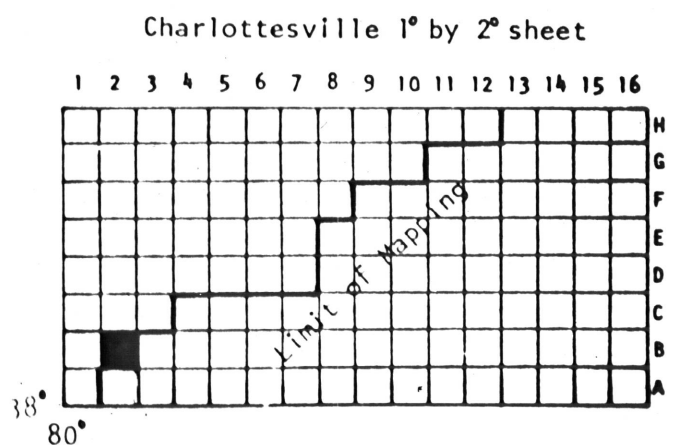
The first five digits of the open file number designate the
specific 1:250,000 scale map sheet of which this quadrangle
is a part. The last two digits designate the position of the
quadrangle in a subdivision of the 1:250,000 scale map based
on rows and tiers shown in the diagram to the right. The
location of this quadrangle is shown by the black square.
